## Effective Vibration-Based Anomaly Detection in Water Pump Operation Using Arduino Microcontroller

Arduino microcontroller and ADXL accelerometer are commonly paired devices, often considered for creating inexpensive vibration analysers. Many researchers have proven that both pairing devices have good performance in vibration measurement and have the potential for commercialisation. This study evaluates the feasibility of vibration measurement and monitoring using an Arduino microcontroller with an inexpensive accelerometer in detecting anomalies during water pump operation. A dedicated Arduino Mega and an ADXL345 accelerometer were attached to a water pump motor to facilitate continuous monitoring of vibrations. The vibration measurement was set at a sampling rate of 530 Hz. Vibration data in RMS value was sent to the cloud storage for monitoring. Raw data captured during normal and abnormal conditions were collected at the

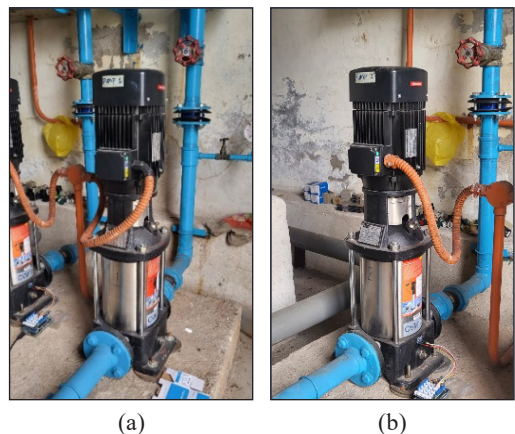
Figure 1. (a) Water pump No.1; and (b) Water pump No.2

As previously mentioned, two units of similar Vertical Multistage centrifugal-type water pumps are utilised for the building, operating alternately. The specifications of these water pumps are detailed in Table 1.

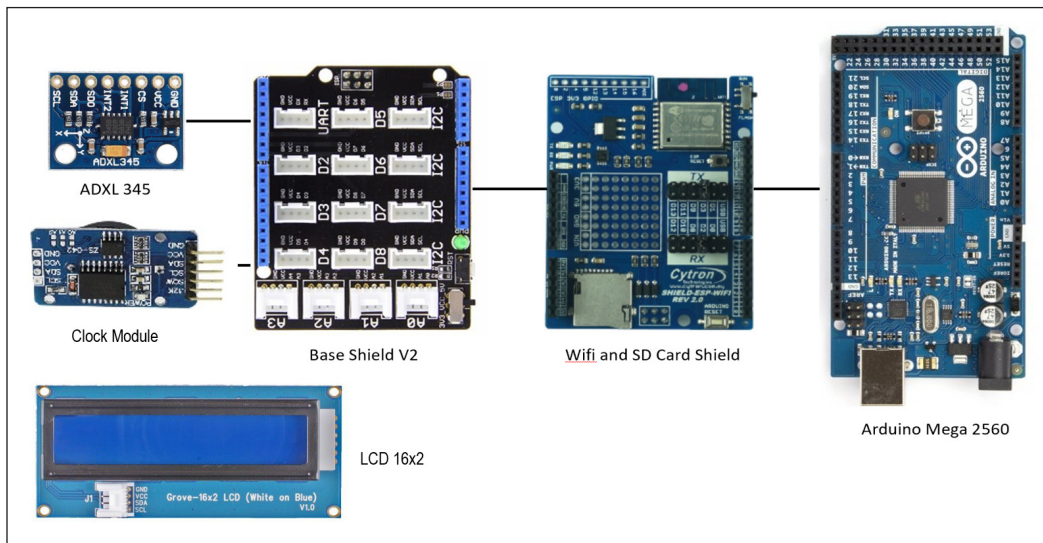
Figure 2. ADAQ component

The design process began with defining the system requirements and selecting appropriate components to meet these requirements. Key considerations included ensuring compatibility between the Arduino Mega 2560 and the ADXL345 accelerometer, as well as integrating additional components for comprehensive functionality. Challenges faced during the design process included optimising data sampling rates and ensuring reliable data transmission. Careful accelerometer calibration was performed to address these challenges, and the software was programmed to handle data storage and transmission efficiently. ADAQ integrates an Arduino Mega 2560 microcontroller and an ADXL345 accelerometer, facilitating real-time data collection and analysis. Additional components include a microSD card adapter, a clock module, and an ESP8266 Wi-Fi module for internet connectivity. All components are shown in Figure 2, and their functions are listed in Table 2. The integration of these components required meticulous wiring and configuration to ensure proper communication and data flow. The ADAQ setup enables efficient monitoring of vibration levels in three axes (X, Y, Z) to assess pump performance.

The ADXL345 accelerometer could sample at a maximum rate of 530 points per second, which was limited by the components, instructions and ability of the microcontroller. The samples taken per measurement were set to 299 points per second to accommodate the dynamic memory's limitations to optimise data collection. Additionally, challenges related to ensuring stable and accurate sampling were addressed through thorough testing and adjustment of the sampling parameters.

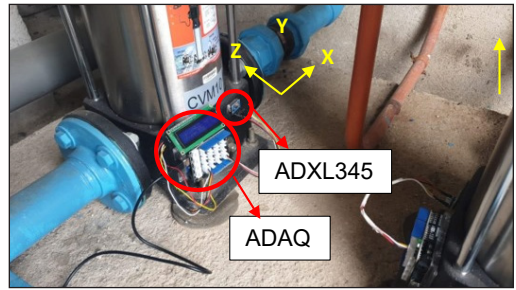
The installation of ADAQ on water pump motors involved mounting the ADXL345 accelerometer on each pump to measure vibration levels, as shown in Figure 3. It allowed for real-time monitoring of pump vibrations in the water pump room. During installation, challenges included ensuring the secure placement of the accelerometer and minimising potential interference from other equipment—solutions involved using appropriate mounting techniques and shielding to enhance measurement accuracy. Vibration measurements were converted to root-mean-square (RMS) acceleration values and transmitted to the cloud system for analysis. Additionally, raw vibration data was stored on the microSD card for further offline analysis.

Figure 3. ADAQ installation at the water pump motor showing all axes' direction

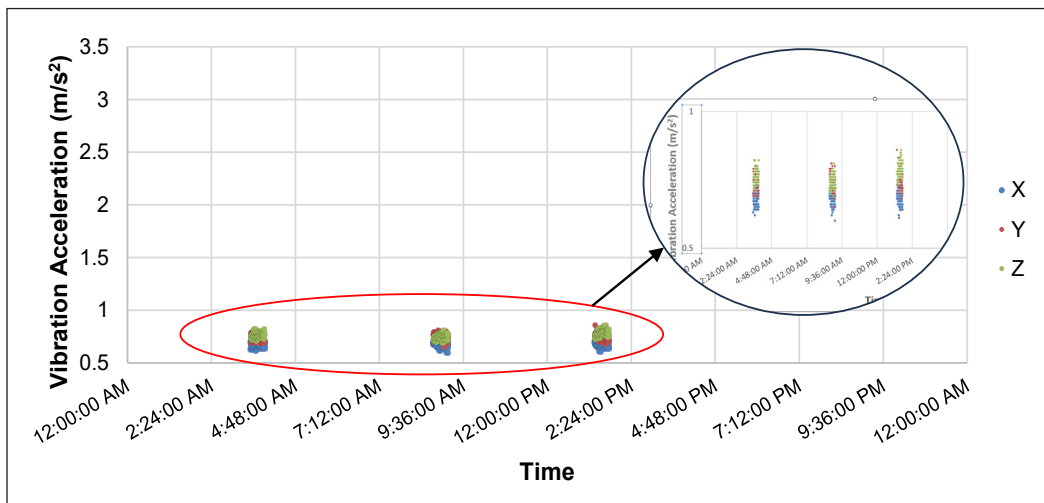
Figures 4, 5, and 6 show vibration data measured at the water pump for 3 days before, during, and after the detected anomalies. The RMS value on 1<sup>st</sup> April 2023 did not fluctuate much and was stable throughout the day. The RMS values of all the axes were not significantly different, with the maximum amplitude value at  $0.82 \text{ m/s}^2$ .

Figure 4. Vibration measured at the water pump on 1<sup>st</sup> April 2023

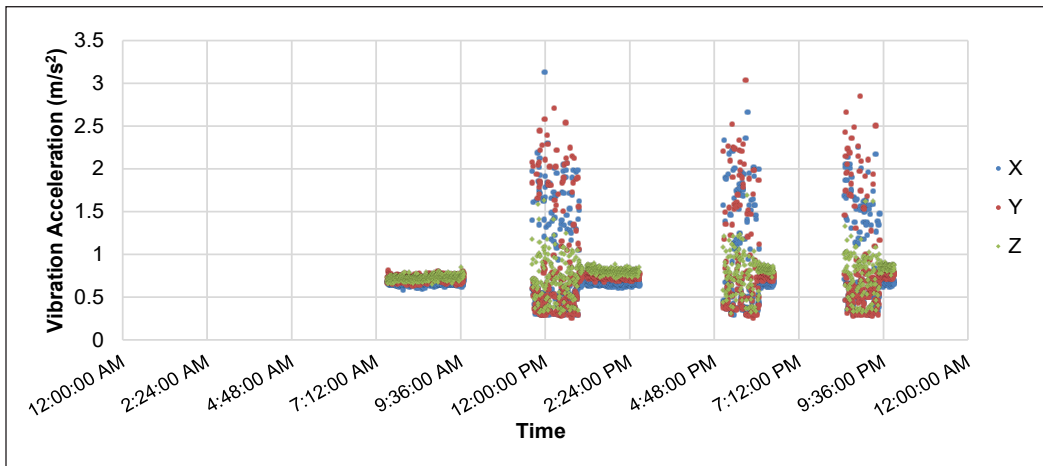
On 3<sup>rd</sup> April 2023, the RMS vibration values in the x, y, and z axes surged to higher-than-normal levels compared to the previous operational period, beginning around 11:37 a.m., immediately after the pump restarted (Figure 5). This abnormal vibration continued on 4<sup>th</sup> April 2023, with the maximum RMS vibration value reaching up to  $2.89 \text{ m/s}^2$ , as

Figure 5. Vibration measured at the water pump on 3<sup>rd</sup> April 2023

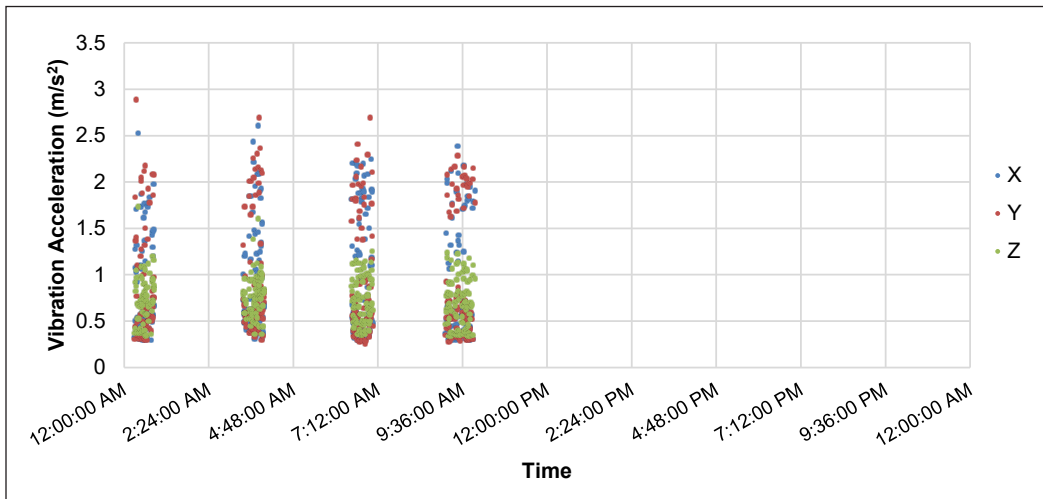
Figure 6. Vibration measured at the water pump on 4<sup>th</sup> April 2023

depicted in Figure 6. Subsequently, the pump was shut off and scheduled for maintenance and repair work.

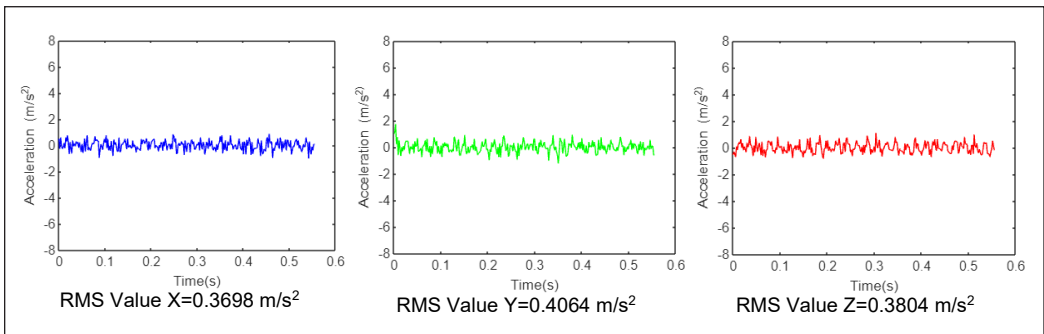
The summary of RMS values for the X, Y, and Z axes during normal (Figure 7) conditions and abnormal conditions (Figure 8) reveals distinct patterns. In normal conditions, the RMS values are relatively low:  $X=0.3698 \text{ m/s}^2$ ,  $Y=0.4064 \text{ m/s}^2$ , and  $Z=0.3804 \text{ m/s}^2$  indicating minimal vibration intensity along each axis. Conversely, notably higher RMS values are observed during abnormal conditions:  $X=1.0365 \text{ m/s}^2$ ,  $Y=1.1342 \text{ m/s}^2$ , and  $Z=0.5912 \text{ m/s}^2$ .

Figure 7. Vibration acceleration (time domain) - NORMAL CONDITION

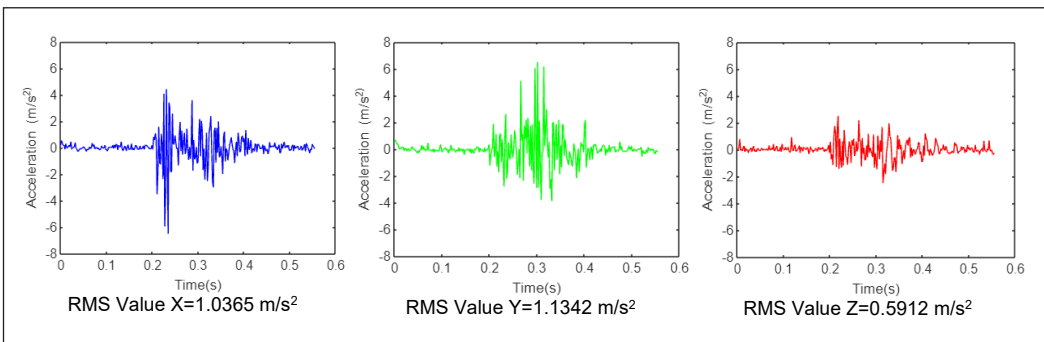
Figure 8. Vibration acceleration (time domain) - ABNORMAL CONDITION

This significant increase in RMS values suggests a substantial amplification of vibration intensity across all axes during abnormal conditions. Moreover, the time domain graphs corroborate these findings, showing a distinct pattern of sporadic spikes in vibration intensity during abnormal conditions, contrasting with the smoother, more uniform pattern observed during normal conditions. This discrepancy underscores the efficacy of RMS values as indicators of abnormal vibration behaviour, with higher RMS values corresponding to pronounced irregularities in vibration patterns. These results suggest that monitoring RMS values provides a reliable method for detecting and distinguishing between normal and abnormal conditions in vibration analysis, facilitating timely intervention to prevent potential equipment malfunction or failure.

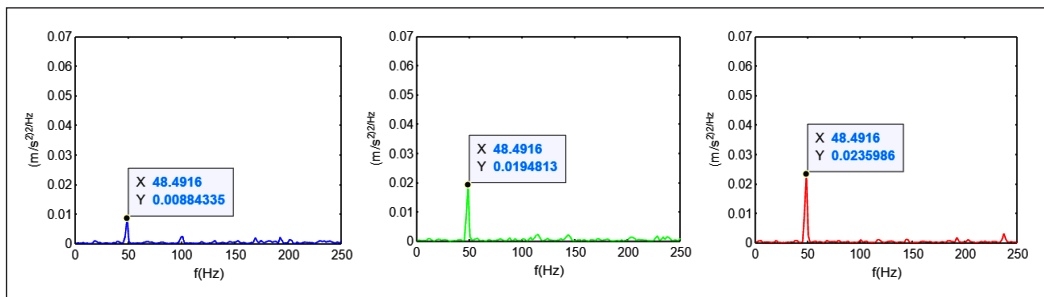
The frequency domain analysis shows distinct differences between normal and abnormal conditions. During normal conditions, the graph prominently displays the blade pass frequency (BPF) or  $1 \times$  frequency across all axes, with the occasional presence of higher harmonics up to  $5 \times$  frequency on certain axes (Figure 9). This characteristic pattern is indicative of stable and consistent machinery operation. However, in the abnormal frequency domain graph, while BPF remains discernible, the graph exhibits irregularities above the BPF, manifesting as random frequencies (Figure 10). This deviation from the

Figure 9. Vibration acceleration (frequency domain)—NORMAL CONDITION

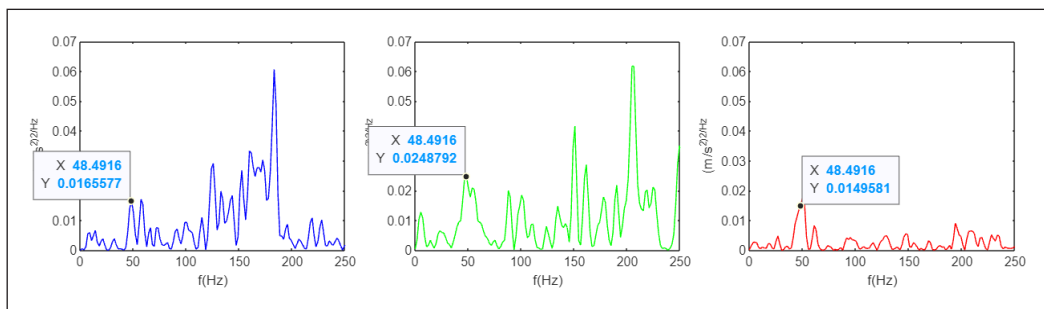
expected pattern suggests the presence of anomalous vibration behaviour, potentially attributable to cavitation effects. Cavitation was induced by operating the pump under conditions of low NPSH (Net Positive Suction Head) and high flow rates, which promote cavitation (Sanchez et al., 2018). Verification of cavitation involved observing the characteristic changes in vibration frequency and amplitude patterns consistent with the symptoms of cavitation described in the literature (Hajnayeb et al., 2017; Abdulaziz & Kotb, 2017). Cavitation-induced irregularities in the frequency domain graph serve as a critical indicator of machinery malfunction or inefficiency, highlighting the importance of frequency domain analysis in detecting and diagnosing operational abnormalities in mechanical systems.

Figure 10. Vibration acceleration (frequency domain)—ABNORMAL CONDITION

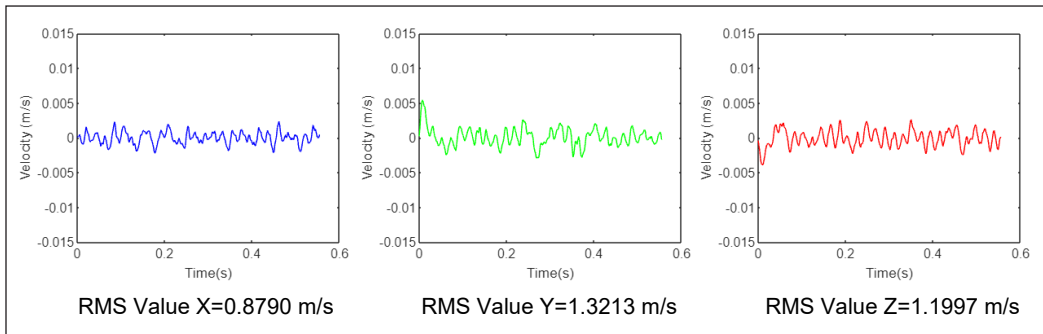
The analysis of vibration velocity in the time domain reveals notable differences between normal and abnormal conditions. During normal conditions, the RMS values for vibration velocity are relatively low:  $X=0.8790$  m/s,  $Y=1.3213$  m/s, and  $Z=1.1997$  m/s, indicating moderate vibration intensity along each axis (Figure 11). Conversely, during abnormal conditions, significantly higher RMS values are observed:  $X=2.2012$  m/s,  $Y=2.2940$  m/s, and  $Z=1.5368$  m/s, indicating a substantial amplification of vibration intensity across all axes (Figure 12). This consistent pattern persists even when converting from acceleration to velocity, underscoring the persistence of abnormal vibration behaviour across different domains. Such pronounced differences in vibration velocity between normal and abnormal

Figure 11. Vibration velocity (time domain)—NORMAL CONDITION

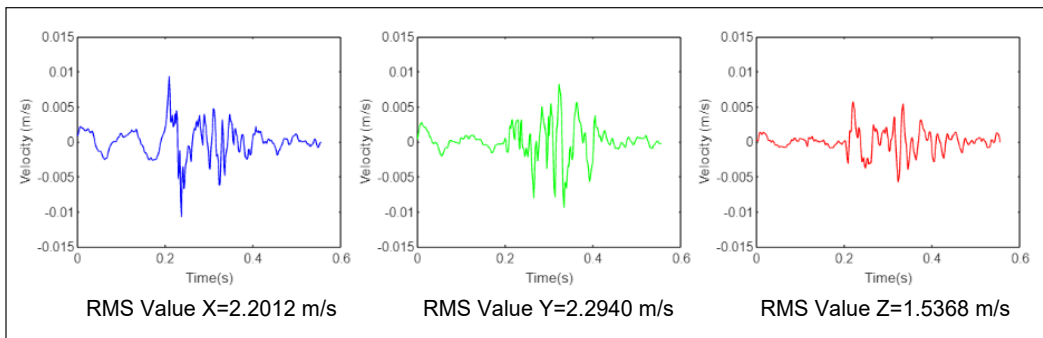
Figure 12. Vibration velocity (time domain)—ABNORMAL CONDITION

conditions highlight the potential severity of operational irregularities, necessitating prompt attention and intervention to mitigate potential equipment damage or failure.

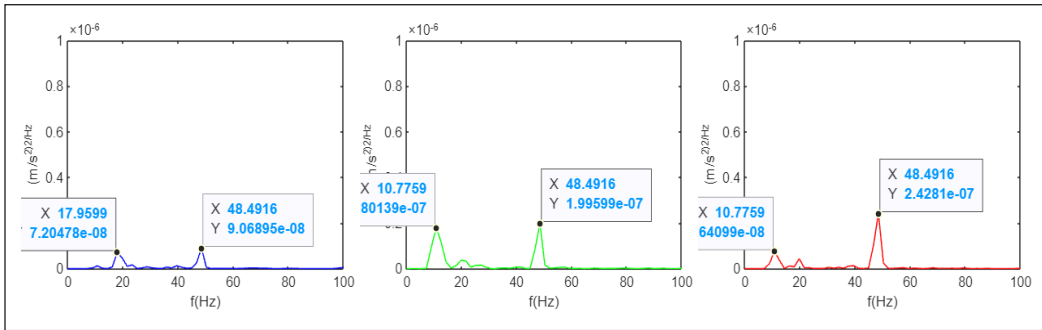
In the frequency domain analysis of vibration velocity, distinct differences between normal and abnormal conditions emerge. During normal conditions, the blade pass frequency (BPF) remains clearly identifiable across all axes, indicating stable machinery operation (Figure 13). However, during abnormal conditions, while the BPF is still discernible in the X axis at 48.4916 Hz, significant alterations occur in the Y and Z axes, where the BPF shifts to 46.6957 Hz and 52.0836 Hz, respectively (Figure 14). This deviation in BPF frequencies across axes suggests irregularities in machinery operation, potentially indicative of underlying faults or inefficiencies. The changes in BPF frequencies align with known symptoms of cavitation, which typically affects the frequency spectrum and can shift the BPF due to changes in the pump (Kafeel et al., 2021). However, the absence of frequency peaks above the BPF complicates fault determination, as vibration velocities beyond the BPF fail to provide conclusive indications of pump system malfunctions. It underscores the limitations of using vibration velocity in the frequency domain for fault diagnosis in such monitoring scenarios, necessitating complementary diagnostic approaches for comprehensive system assessment.

Figure 13. Vibration velocity (frequency domain)—NORMAL CONDITION

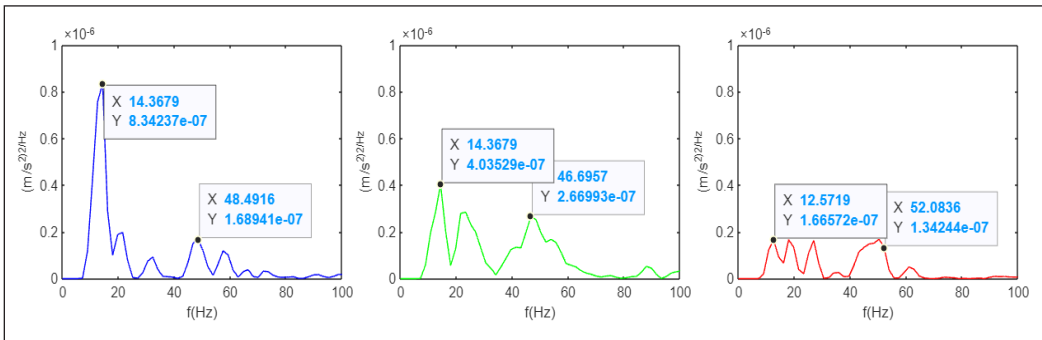
Figure 14. Vibration velocity (frequency domain)—ABNORMAL CONDITION

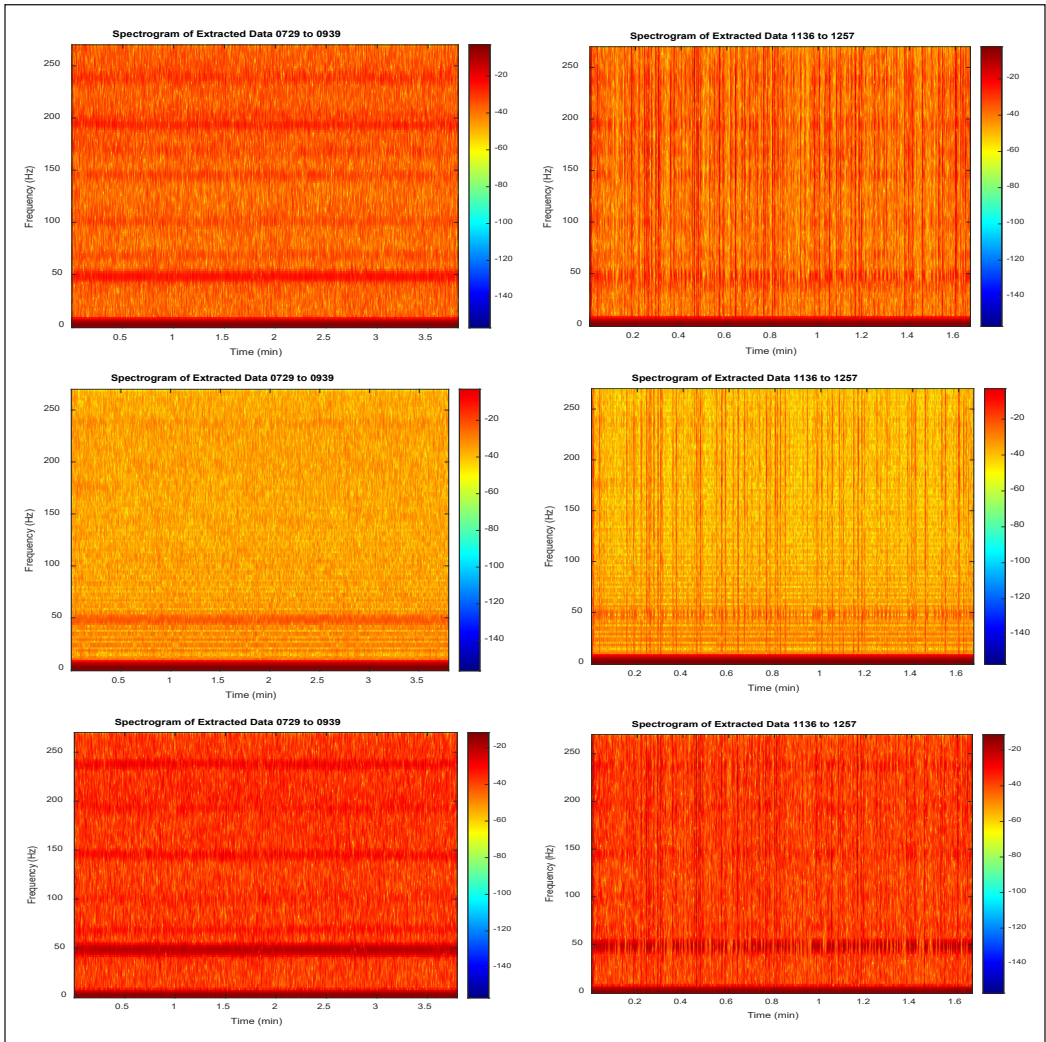
Based on the raw data, vibration spectrograms were generated for normal and abnormal conditions across all axes (Figure 15). During normal conditions, the spectrograms clearly indicate the blade pass frequency (BPF) in all axes, with additional harmonics observed up to  $5 \times$  frequency on the X and Z axes. This consistent pattern suggests stable machinery operation and a well-defined frequency distribution. However, in abnormal spectrogram graphs, the smoothness of the graph is notably disrupted, indicating irregularities in vibration patterns. These disruptions are consistent with cavitation effects, which can cause fluctuating and erratic patterns in the spectrogram. These disruptions may signify the presence of anomalies or faults within the system, potentially leading to inefficiencies or malfunctions. Further analysis of the abnormal spectrogram graphs is warranted to pinpoint the specific nature and severity of these irregularities, facilitating timely intervention and maintenance to ensure optimal system performance and reliability.

Figure 15. Vibration spectrogram graph during NORMAL conditions (left) and ABNORMAL conditions (right) for all axes, respectively

The investigation into vibration patterns in both time and frequency domains, alongside spectrogram data analysis, reveals key findings consistent with prior research. Under normal operating conditions, stable machinery performance is indicated by consistent patterns

across various axes, including blade pass frequency (BPF) and harmonics (Bai et al., 2019). Conversely, abnormal conditions exhibit significant deviations from these established patterns, manifesting irregularities in vibration intensity and frequency distribution (Karagiovanidis et al., 2023). This discrepancy suggests the presence of anomalies or faults within the system, aligning with previous studies investigating factors such as cavitation or mechanical wear (Krishnachandran et al., 2020). Furthermore, the limitations of vibration velocity analysis in the frequency domain for fault diagnosis underscore the need for complementary diagnostic approaches. Overall, the comprehensive analysis of vibration data reveals valuable insights into the operational status of the pump system, highlighting
